KOOTENTAI DEVELOPMENT IMPOUNDMENT DAM TOE DRAIN INSPECTION REPORT

APRIL 1, 2010

BHI File No.: R.56.1

Kurt Hafferman, P.E.
April 1, 2010

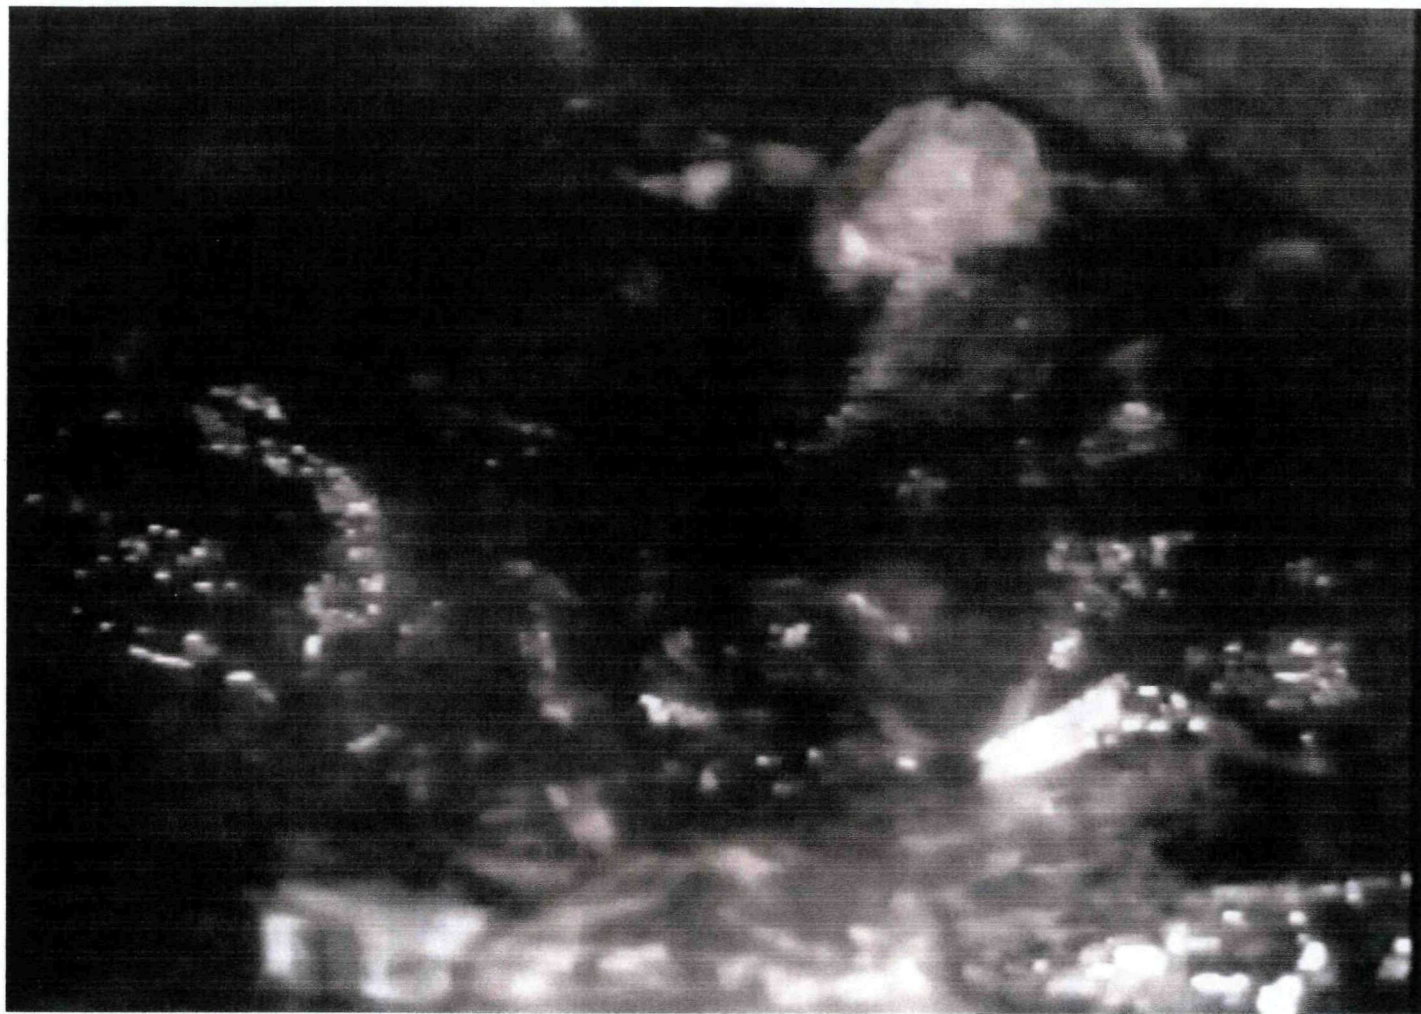
Drain 9: Angular Rock at the end of Drain 9

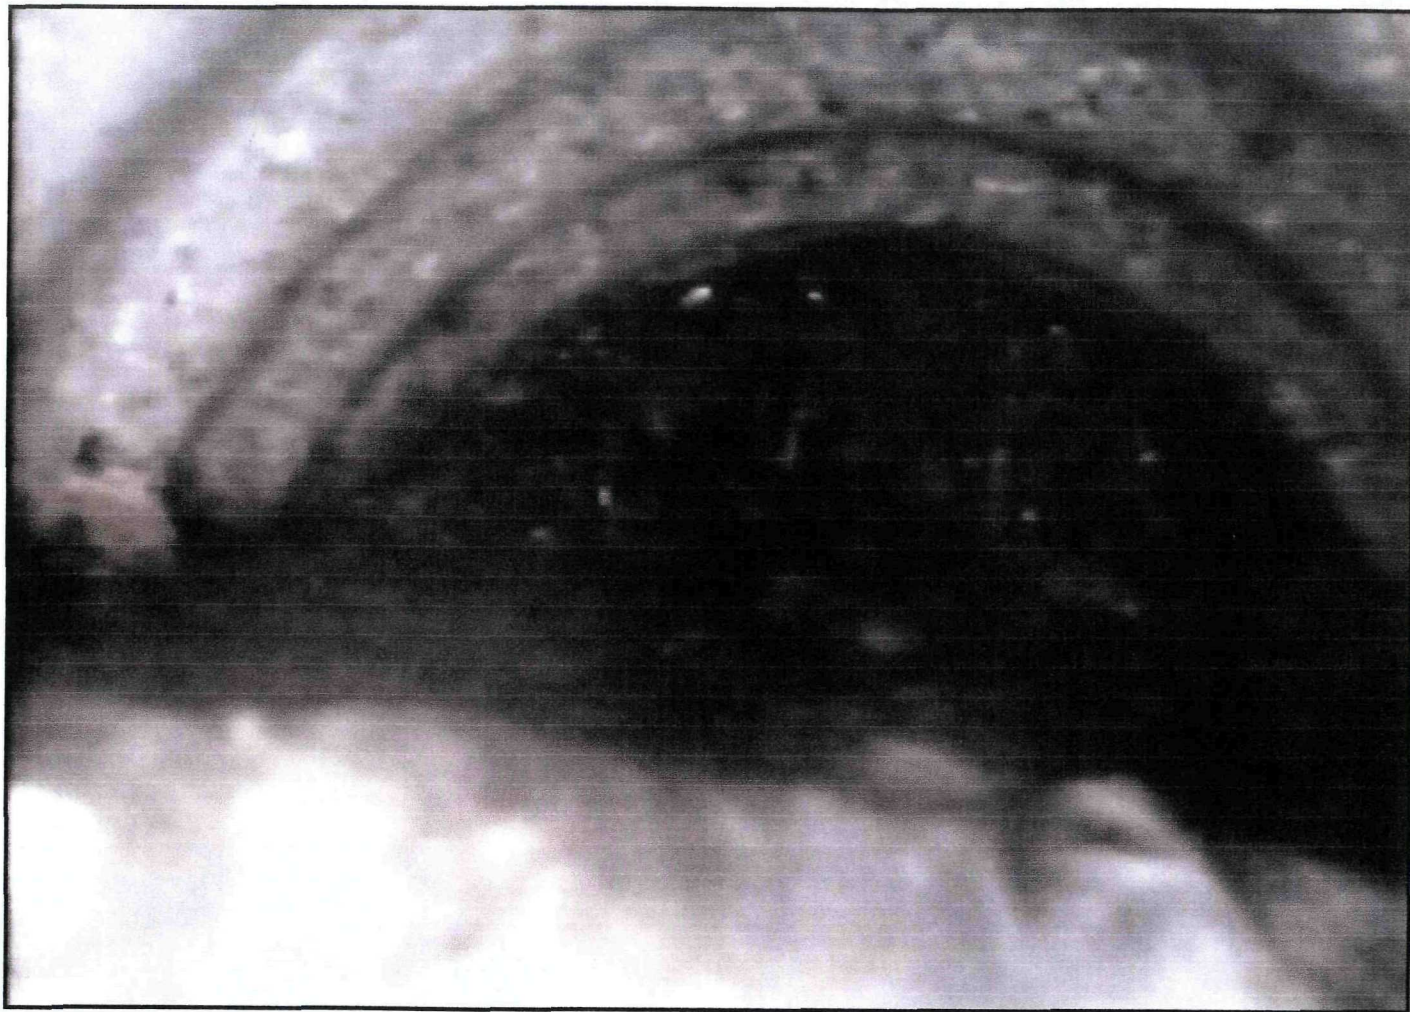
Drain 10: Concrete headwall or bell end of pipe at end of 10-inch CMP drain

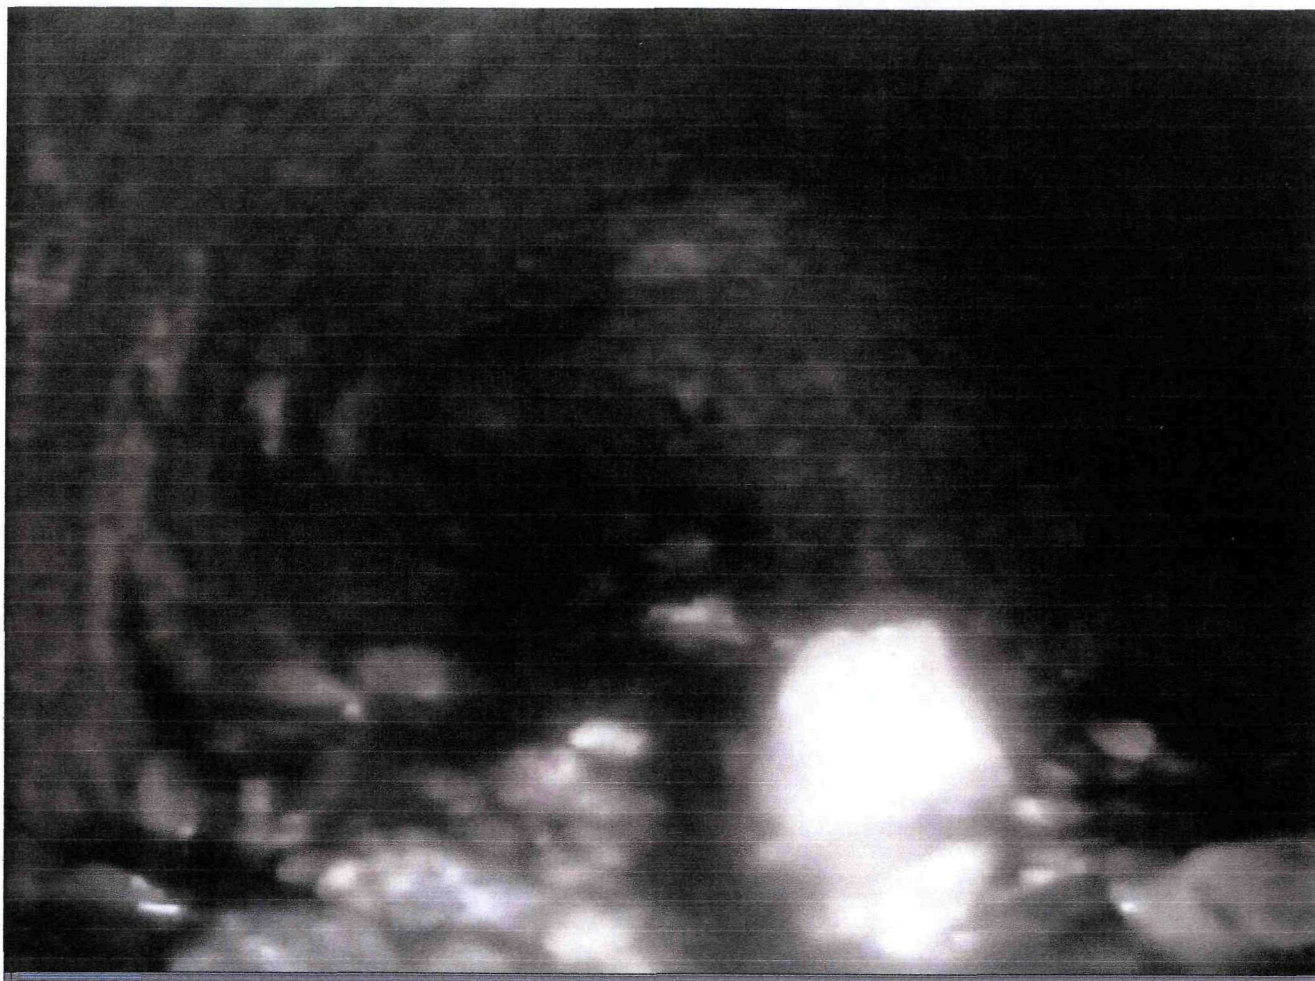
Drain 11: Larger Rocks at near the end of Drain 11

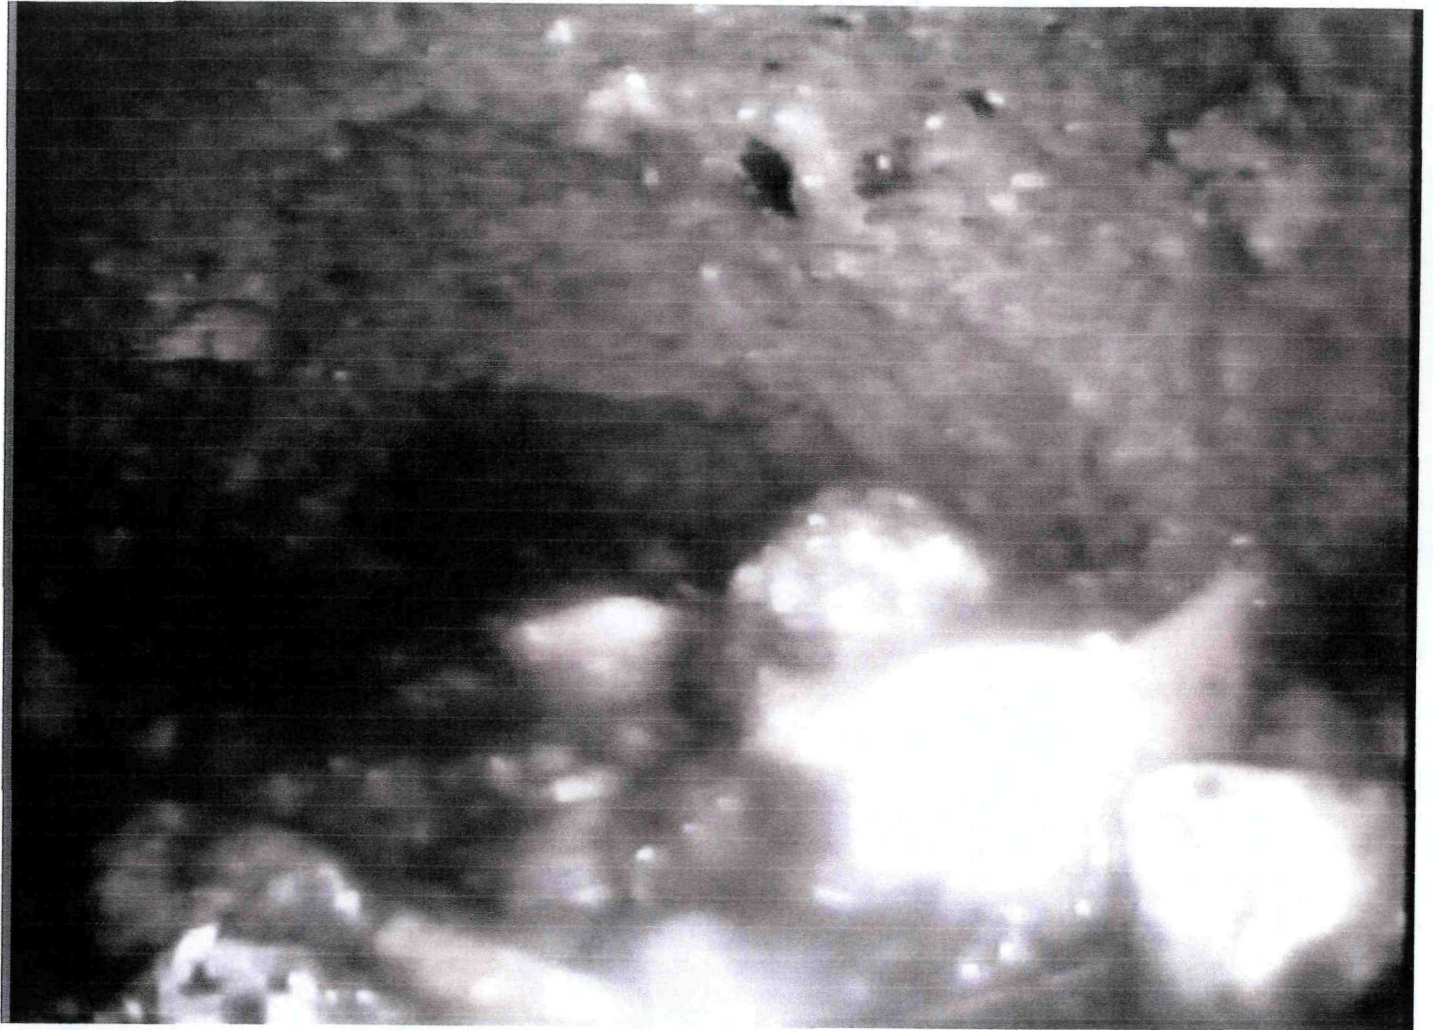
Drain 11: Large rocks and void space at the end of Drain 11

3. The void space at the terminal end of drain 11 should be excavated. If the void is left in the embankment it is likely that the roof of the space will eventually collapse and may block the drain or wash more embankment material out and create a bigger void or a depression on the surface. As the terminal end of the drain is located less than 15 ft. from the end and as the overburden above the end is estimated to be less than 5 ft., it is recommended that drain 11 be excavated and that washed drain rock be placed in the void space. While the excavation occurs

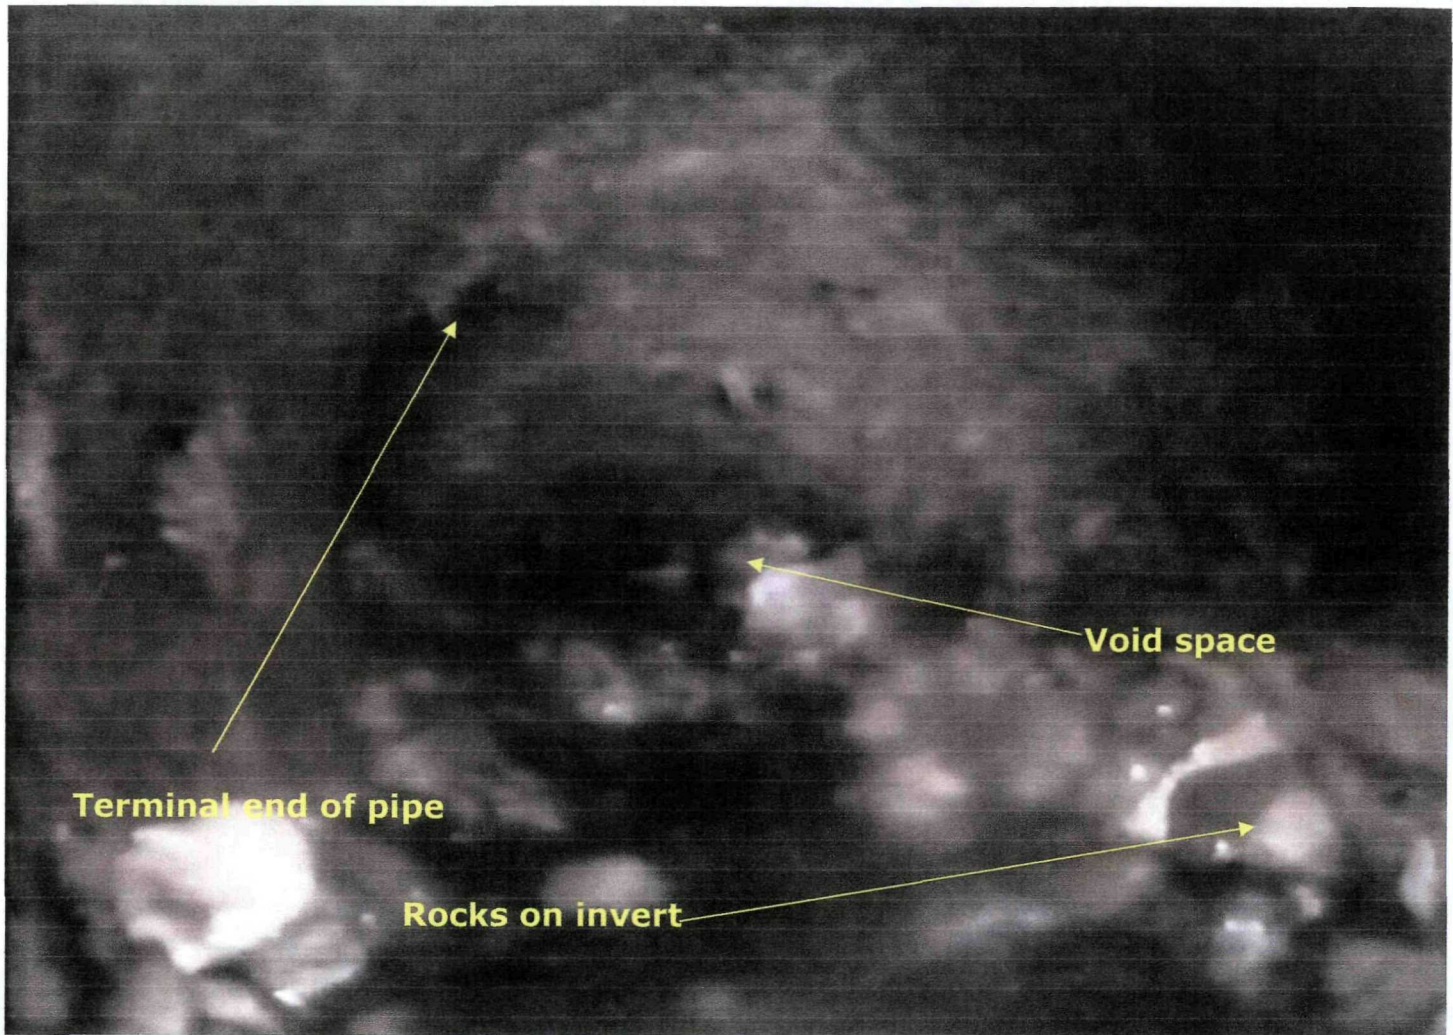
Drain 11: Terminal end of pipe, rocks on invert and void space at the end of Drain 11

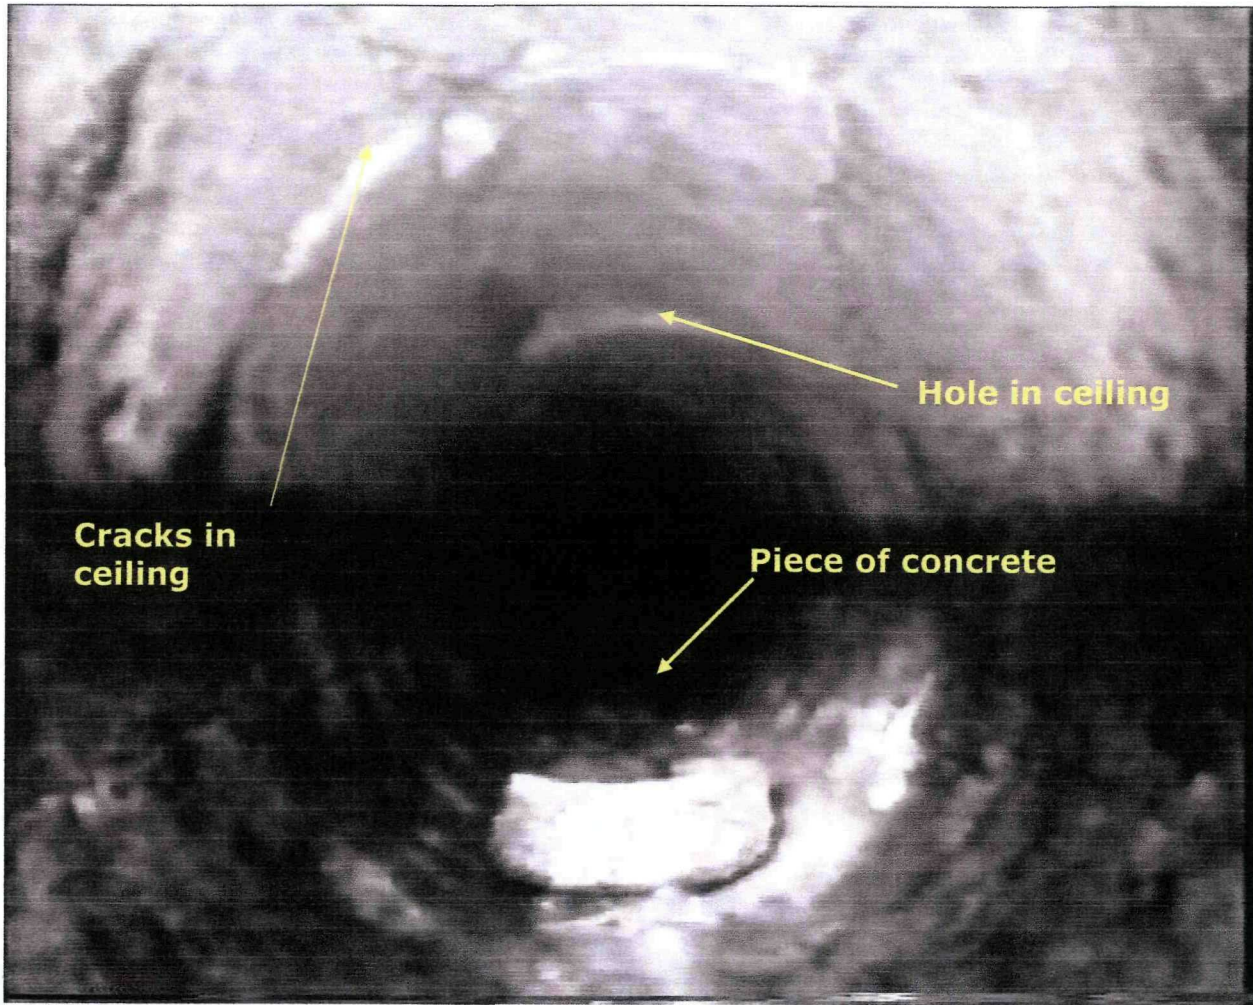
Drain 12: Cracks in ceiling and concrete piece in pipe
